CELL :- A431 CELL NAME:-De-comp assy MACHINE / STAGE:-Riveting process OPERATION : 10

KAIZEN THEME :- : A431 De-Comp Assay
Functional problem after assembly in Engine Assy

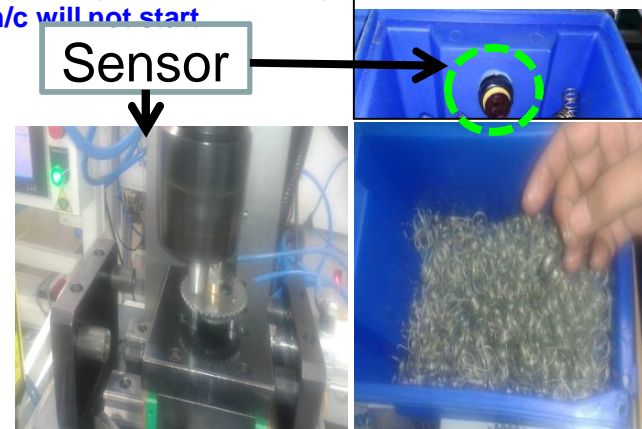
BEFORE

PROBLEM / PRESENT STATUS :-
:-To Prevent the customer complaint : A431 De-Comp Assay Functional problem after assembly in Engine Assy

Manual process

Why 1- 2LP De comp assembly functional problem at Engine assy @ Yamaha.

Why 2- De comp assembly fly-weight free movement

Why 3- Spring missed in De comp assembly

Why 4- Manual process (Poka)

ROOT CAUSE: POKA
