# QUALITY IMPROVEMENTS – A225 PRV

<b>ADVIK</b>	TPM Circle No.:	Activity	KK	JH	QM	PM	SHE	OT	DM	E&T	<b>KAIZEN IDEA SHEET</b>	
	TPM Circle Name:	Loss no.										
Plant-1 Chakan	Dept.: Machine Shop	Step									<b>Kaizen No.:</b>	
Cell No.: 01	Cell Name: A225 relief valve	Result Area	P	Q-		C	D	S	M			
		Process / Stage : CNC-8							Operation : Machining			
<b>Kaizen Theme:</b> To eliminate concentricity rejection		<b>Idea :</b> Tail stock center provided on machine to avoid job deflection in running.										
		<b>Counter Measure:</b> 1) One side tail stock center provided.										
<b>Problem / Present Status:</b> 1) Concentricity of A225 prv not ok ID TO OD. 2) Wall thickness found -		<b>Before :</b>				<b>Bench Mark</b>			500

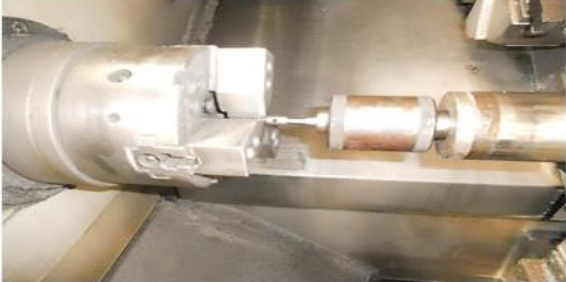
P	Productivity increased					
						Q	Concentricity ok					
						C						
						D						
						S						
						M						
						<b>Kaizen Sustenance :</b>						
						<b>What to do :</b> Tailstock clamping to be provided on machine.						
						<b>How to do :</b> Ensure tailstock clamping while PRV machining.						
<b>Why Why Analysis :</b>		<b>After :</b>										
Why 1) ID not concentric to OD

Why 2): During OD turning component clamped incorrectly.												
Why 3) Job deflect in running condition.												
.												
<b>Root cause-</b> Job deflect in running condition.												
.												
						<b>Result :</b> 1) Concentricity ok 2) Productivity is increased . 3) Quality improve.						
<b>Registration no.&amp; dt :</b> :20/05/14						<b>Scope &amp; Plan for Horizontal Deployment</b>						
<b>Submitted by :</b> Someswer						<b>Sr. no.</b>	<b>Model</b>	<b>Target Date</b>	<b>Responsibility</b>	<b>Status</b>
