CELL :- A410 CELL NAME:- oil pump MACHINE / STAGE :- VMC OPERATION :- Reaming

KAIZEN THEME –To avoid A410 Body Dia. 8.0 Hole damage

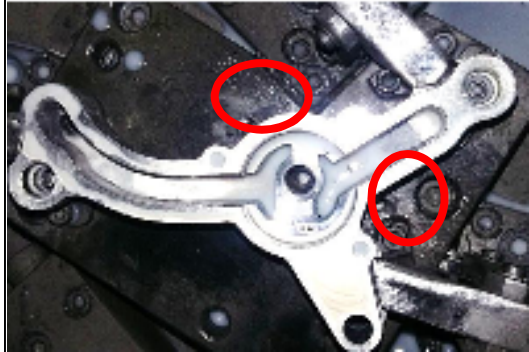
BEFORE

PROBLEM / PRESENT STATUS –A410 Body Dia. 8.0 Hole damage

WHY - WHY ANALYSIS :-
Why 1 – A410 Body Dia. 8.0 Hole damage
Why 2 – Part not locate in locating hole.
Why 3 – Wrong Load.
Why4 – Current process allows wrong loading .

ROOT CAUSE- -- Current process allows to wrong load.
