CELL :- A239 B CELL NAME:- Oil Pump MACHINE / STAGE :- VMC OPERATION :- Tripping

KAIZEN THEME –To avoid A239 Body line mark observed on Dia. 60.0

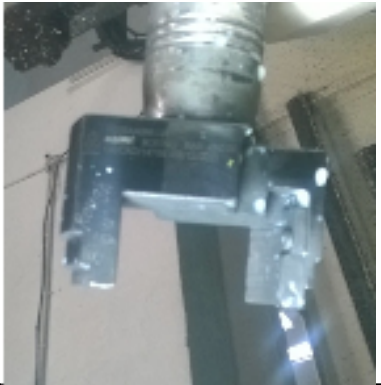
BEFORE

PROBLEM / PRESENT STATUS –A239 Body line mark observed on Dia. 60.0

Why 1 – A239 Body line mark observed on Dia. 60.0mm.

Why 2 – Line mark occur during tool homing Position.

Why 3 – Wrong direction select for tool loading.

ROOT CAUSE- –No procedure displayed on line .
