CELL :- A373      CELL NAME:- oil pump Cover      MACHINE / STAGE :- CNC      OPERATION :- facing

**KAIZEN THEME** –To avoid A373 Cover Thickness 5.0 undersize

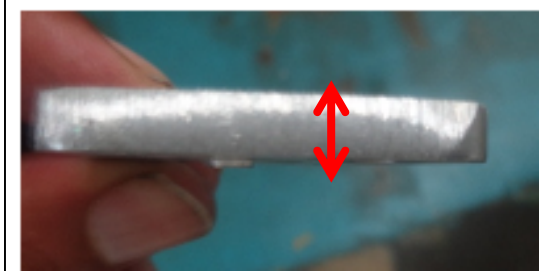
**BEFORE**

**PROBLEM / PRESENT STATUS** –A373 Cover Thickness 5.0 undersize. Spec – 5.0 ± 0.1,Actual- 4.62mm

**WHY - WHY ANALYSIS :-**  
**Why 1** – A373 Cover Thickness 5.0 undersize  
**Why 2** – Wrong offset Taken.  
**Why3** – After locking control panel machine take offset in Geometry offset.  
**Why4** – Current process allows to wrong offset.

**ROOT CAUSE-** -- Current process allows to wrong offset.
