TPM CIRCLE NO :-	ACTIVITY	KK	QM	PM	JH	SHE	OT	DM	E&T	KAIZEN IDEA SHEET																				
		TPM CIRCLE NAME :	LOSS NO. / STEP										KAIZEN NO:-01																			
		DEPT :- IQA	RESULT AREA	P	Q	DEF:- A	C	D	S	M																						
CELL :-A314	CELL NAME:-Oil Pump Assembly	MACHINE / STAGE :Milling						OPERATION :-Slot Milling																								
KAIZEN THEME To prevent Occurrence of rotation jam Issue in A314 Oil Pump Assembly			IDEA :- Detection Type Pokayoke to be provided on D-Milling M/C .																													
WIDELY/DEEPLY:-			COUNTERMEASURE:-					BENCHMARK 01 No.																								
PROBLEM / PRESENT STATUS :- A314 Oil pump can't rotate smoothly /Jump after assembled in crankcase (A314 Shaft symmetry NG With respect to OD 6.8mm.)

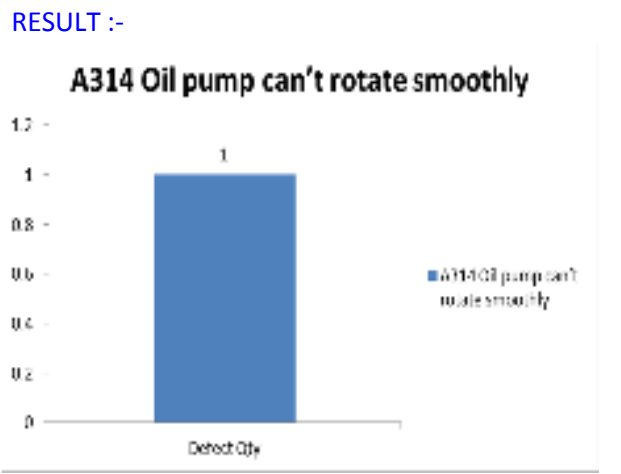
Part	Standard	Actual	Judge	a	1.6~1.8	1.91	NG	b	±0.102	0.14	OK	c	1.6~1.8	1.46	NG	d	0.05 ^{+0.02} _{-0.02}	0.12	OK	BEFORE					AFTER				
Part	Standard	Actual	Judge																													
a	1.6~1.8	1.91	NG																													
b	±0.102	0.14	OK																													
c	1.6~1.8	1.46	NG																													
d	0.05 ^{+0.02} _{-0.02}	0.12	OK																													
WHY - WHY ANALYSIS :- Why 1: A314 Oil pump can't rotate smoothly /Jump Why 2: Symmetry of U Milling wrt to OD NG (Spec 0.1 & actual 0.25mm Why 3- Lug wall thickness variation one side 1.91 & other side 1.46 (0.45mm) spec 1.6-1.8mm) Why 4- Setting rejection Mix-up & not detect in next process .			RESULT :-

ROOT CAUSE: Setting rejection Mix-up & not detect in next process .			WHAT TO DO :- Check point Added In Supplier action plan sustenance sheet & change process flow diagram HOW TO DO : Verify the action plan - FREQUENCY – As Per supplier Audit plan.																													
REGISTRATION NO &DATE::14.07.2014			COST INCURRED FOR MAKING KAIZEN																													
REGISTERED BY :- Parmeshwar Bansode			MATERIAL COST IN RS		LABOUR COST IN RS		TOTAL COST IN RS																									
MANAGER'S SIGN :- Sunil Kinkar			-----		-----		-----																									
SCOPE & PLAN FOR HORIZONTAL DEPLOYMENT																																
Sr. NO.	CELL	TARGET	RESPONSIBILITY	STATUS																												
1	-----	-----	-----	-----
