CELL :-A247      CELL NAME:- BKT      MACHINE / STAGE :- Drilling -SPM A1      OPERATION :- Drilling

**KAIZEN THEME** –To Avoid A247 BKT Inside dia 5 Counter hole face damage

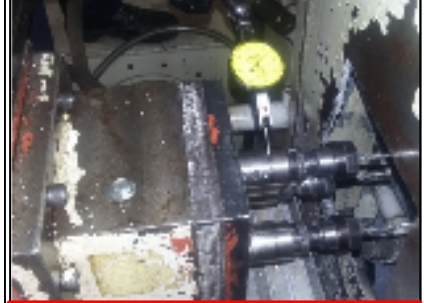
**BEFORE**

**PROBLEM / PRESENT STATUS** –A247 BKT Inside dia 5 Counter hole face damage

Play in spindle 0.35 mm

**WHY - WHY ANALYSIS :-**  
**Why 1** – A247 BKT Counter hole face damage.  
**Why 2** - 4.2 Drill not rotate concentric  
**Why 3** –0.35 Play observed in 4.2 drill spindle (Req.20 mic).  
**Why 4** –Gear box housing wear out ( Gear box ID required 47 & actual 47.5mm ) .

**ROOT CAUSE-** –Gear box housing wear out

**COUNTERMEASURE:** 1) Gear box changed.2) Provide air purging to avoid coolant entry into bearing.

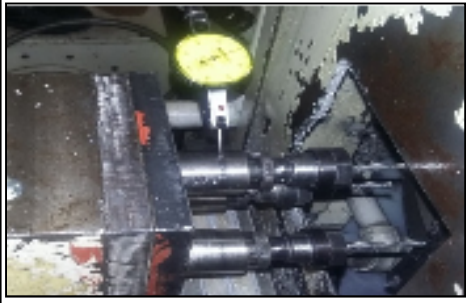
**AFTER**

Play in spindle 0.005 to 0.008 mm
