TPM CIRCLE NO :- 3	ACTIVITY	KK	QM	PM	JH	SHE	OT	DM	E&T
TPM CIRCLE NAME :	LOSS NO. / STEP								
DEPT :- Q.A	RESULT AREA	P	Q	DEF:- A	C	D	S	M

CELL :-A289 Rotor | **CELL NAME:- Rotor Grinding** | **MACHINE / STAGE :- Center less OD grinding** | **OPERATION : Outer Diameter grinding**

KAIZEN THEME :- A289 outer rotor out side diameter damage.

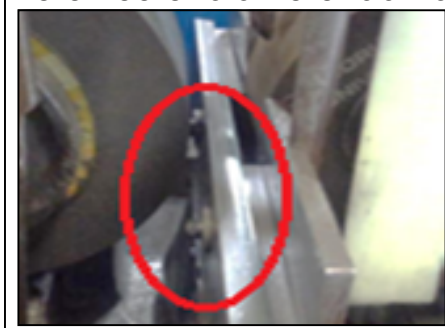
BEFORE

PROBLEM / PRESENT STATUS :- A289 outer rotor outer diameter damage.

No Side plate

WHY - WHY ANALYSIS :-
Why 1 :- A289 outer rotor out side diameter damage .
Why 2 :- During outer diameter grinding ,component split & out side diameter touch to grinding wheel.
Why 3 :- No poka Yoke

ROOT CAUSE:-No poka yoke

1) Poka to be added as side plate provide to avoid component splitting .
