CELL :- A247 BKT CELL NAME:- Bracket MACHINE / STAGE :- SPM OPERATION :- Tapping

KAIZEN THEME –To avoid A247 BKT M8 Tapping hole oversize

PROBLEM / PRESENT STATUS –A247 BKT M8 Tapping hole oversize

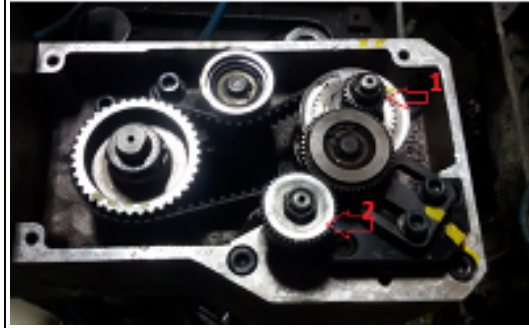
Wrong Gear sequence assembly **BEFORE**

WHY - WHY ANALYSIS :-
Why 1 – A247 BKT M8 Tapping hole oversize.
Why 2 –Cutting Feed low.
Why3 – Feed Gear Ratio Wrong .
Why4 - During assembly of Gear ,sequence of assembly not follow.
Why4 -No awareness

ROOT CAUSE- No awareness

COUNTERMEASURE: 1) Gear Ratio corrected.
2) Before dis assemble & assembly drawing used & sequence follow .
3) Training given to operator

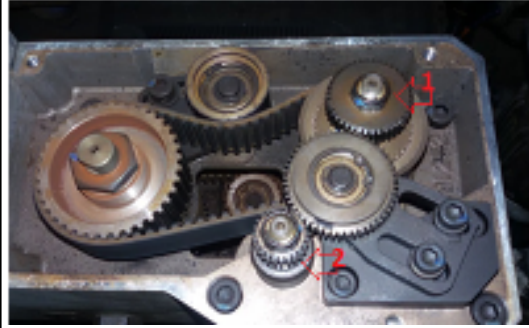
Correct Gear sequence assembly **AFTER**
