CELL :- A247 **CELL NAME:- BKT** **MACHINE / STAGE :- Drilling M/c** **OPERATION : Drilling**

KAIZEN THEME –To avoid A247 Bracket
Dia. 8.1 hole shift

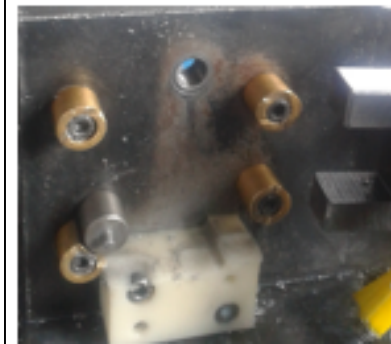
BEFORE

PROBLEM / PRESENT STATUS -A247
Bracket Dia. 8.1 hole shift

Locating pin not available

WHY - WHY ANALYSIS :-
Why 1 – A247 Bracket Dia. 8.1 hole shift.
Why 2 – Locating pin not available on fixture .
Why 3 – fallen from fixture .
Why 4 –No provision to fitted in fixture .

ROOT CAUSE— No provision to fitted in fixture .

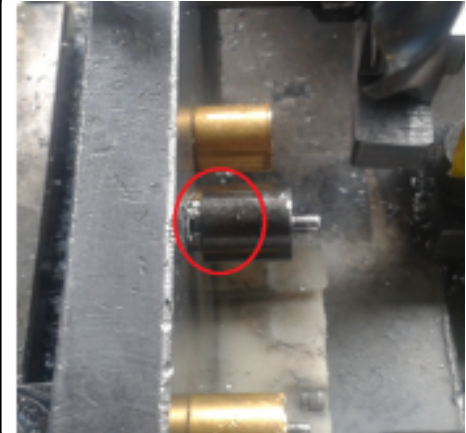
AFTER

Locating pin fitted

COUNTERMEASURE:- Locating pin fitted by bolt with fixture.

WHAT TO DO- Check point added in fixture maintenance sheet .
HOW TO DO: Visual
FREQUENCY : Once in month
