**CELL :- Tensioner** | **CELL NAME:-A157** | **MACHINE / STAGE :- Troub** | **OPERATION : Facing**

**KAIZEN THEME -To avoid** A157 Body Back facing line mark.

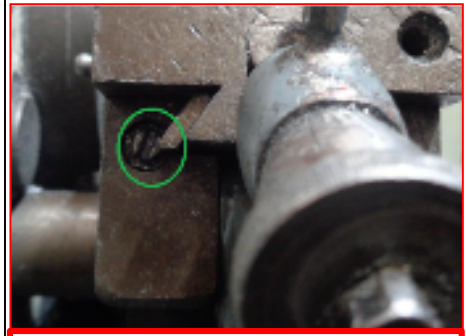
**BEFORE**

**PROBLEM / PRESENT STATUS -**A157 Body Back facing line mark.

Screw loose & worn out

**Why 3** – slide Tightening screw loose.

**Why 4** – Screw head worn out after long use.

**ROOT CAUSE--** Screw head worn out after long use.
