KAIZEN IDEA SHEET

CELL: A533 CELL NAME: Oil Pump Assy. MACHINE / STAGE: Pneumatic Press/Assembly OPERATION: Date Code Punching

KAIZEN THEME: To Prevent May Happen In-house of A533 Oil Pump Assy.

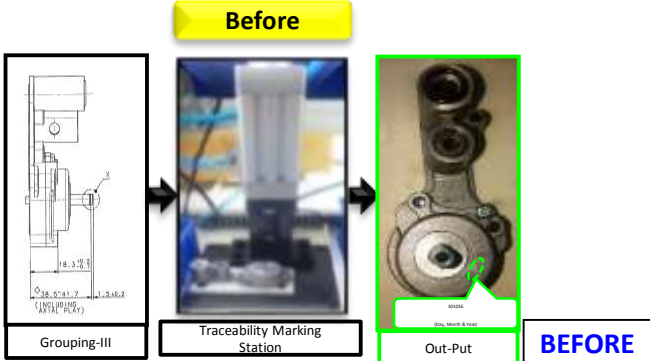
PRESENT STATUS : May chance of Rotation Jam on account of process due to body bend.

- Why1:** May chance of Rotation Jam on account of process due to body bend.
- Why2:** There is no ID face resting for body while date code punching
- Why3:** Date code Punch Operation after body & Cover Assy.

ROOT CAUSE:- Date code Punch Operation after body & Cover Assy

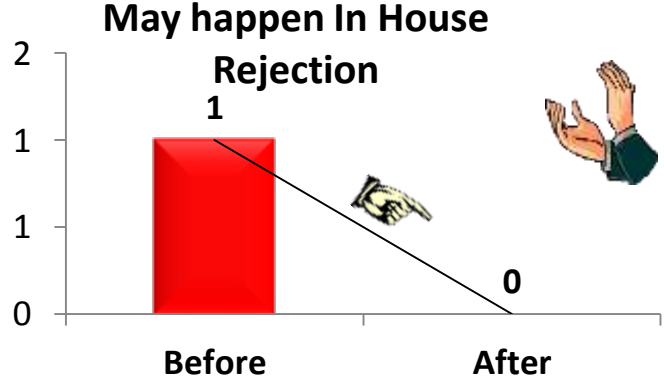
RESULT:-

Before: By luck there is No In House Rejection

After: Prevent May happen in House rejection by improvement

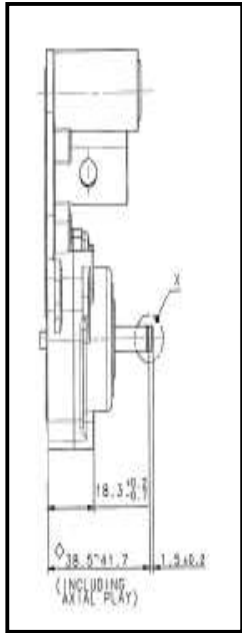
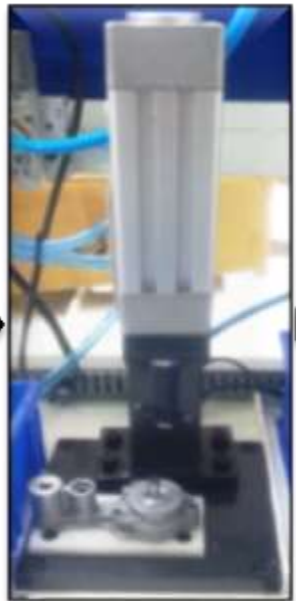
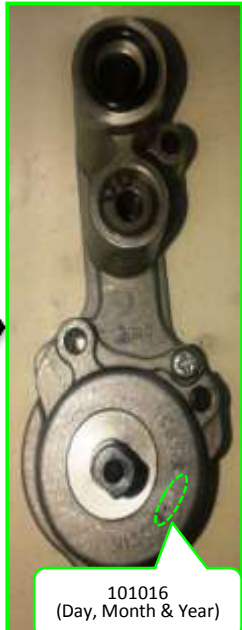
Before

Shifter Traceability marking station before body & Rotor Clearance Inspection - To Eliminate May chance of body get bend ,rotation jam & Improper traceability marking
