CELL :-A328 CELL NAME:- Oil pump Assembly MACHINE / STAGE :- A328 Assembly Line OPERATION :- Assembly Stage

KAIZEN THEME : To Prevent re-occurrence of Customer Complaint of shaft length o/s (10.20mm)

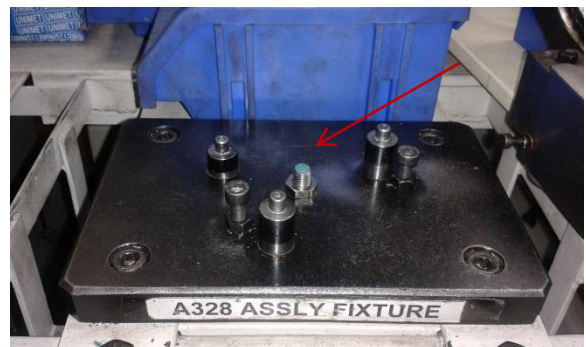
PROBLEM / PRESENT STATUS :- 2 Nos. found at customer end without outer rotor assly.

No provision for arresting 10.20 mm o/s shaft

WHY - WHY ANALYSIS :-
Why1: Oil pump gets jam
Why 2: Shaft gets stuck while assembly
Why 3:-Shaft 10.20 mm dim. found 11.0 mm
Why 4: Milling done manually at supplier end
Why5: No pokayoke on assembly line

ROOT CAUSE :- No pokayoke .

COUNTERMEASURE:- Sensor implemented for 10.20 mm o/s shaft and interlock with Gun.
