CELL :-A247	CELL NAME:- CBS Assembly	MACHINE / STAGE :- A347 Assembly Line	OPERATION :- Flushing Stage
-------------	--------------------------	---------------------------------------	-----------------------------

KAIZEN THEME : To Prevent re-occurrence of Customer Complaint of Parking Lock Not working in CBS Assembly.

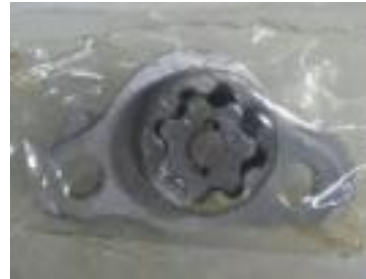
AFTER

PROBLEM / PRESENT STATUS :- 9 Nos. found at customer end without outer rotor assly.

ROOT CAUSE :- Poly bag is not transparent.

COUNTERMEASURE:- Make transparent poly bags for visualize the job at packing time
