ADIK		TPM CIRCLE NO :-	1	ACTIVITY	KK	QM	PM	JH	SHE	OTPM	DM	E & T	KAIZEN IDEA SHEET
Plant : P14		TPM CIRCLE NAME :		LOSS NO./STEP									
CELL :	A529	DEPT :	Production	RESULT AREA	C	Q	P	P, C	S	M, D	P, C	M	
CELL NAME :		Oil Pump Machining	M/C STAGE:	Brother-4	OPERATION:			Op 10 , Facing Reaming & Tapping					
KAIZEN THEME :		KAIZEN IDEA :											
To avoid may happen CC .		Provide relieve to cutting edge of M16 tap.							BENCHMARK:		----		
		TARGET:		----		KAIZEN START:		08.3.18					
PROBLEM PRESENT STATUS :		COUNTERMEASURE:							TARGET DATE:		08.3.18		
Defect generation of hard burr in threaded area.		Provide relieve for cutting edge of the M16 Tap where chips out flows from the PRV hole & thread formation is smooth.							KAIZEN FINISH:		08.3.18		
		TEAM MEMBERS:											
		Mr. Manas Dey											
		BENEFITS:-											
		Defect generation eliminated											
WHY-WHY ANALYSIS:		BEFORE				AFTER				KAIZEN SUSTAINANCE

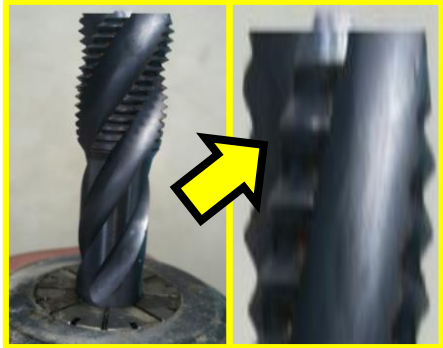
<p>Why1:- Defect generation of hard burr in threaded area.</p> <p>Why2:- Hard thread observed in PRV hole after tapping Operation.</p> <p>Why3:- No Relieve found in M16 Tap cutting edge.</p>

<p>Chance of defect Generation.</p> </div> <div style="text-align: center;">

<p>WHAT TO DO: Check for relieve at tool cutting area in M16 Tap</p> <p>HOW TO DO: During new tool inspection time.</p> <p>FREQUENCY: During new tool changing.</p>			
ROOT CAUSE		RESULTS:											
No relieve found In M16 tap cutting edge.		<div style="display: flex; justify-content: space-around; align-items: center;"> <div style="text-align: center;">

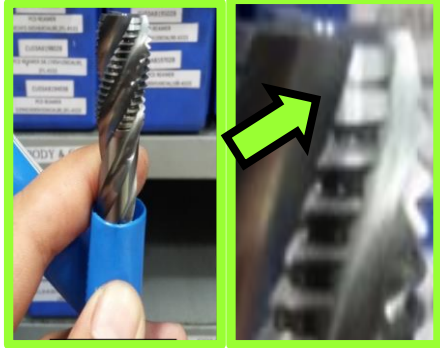
<p>No Chance of defect Generation</p> </div> </div>											
REGISTRATION NO.:		P14/QM/2018/035											
DATE:		30.03.2018											
REGISTERED BY:		Nigama											
MANAGER SIGN:		Mr. Sanjay											
HD SCOPE INFORMATION IN OTHER PLANT													
SR.NO.	CELL/ PRODUCT	TDC	RESP.	STATUS	SR.NO.	PLANT	WHEN	WHOM	STATUS
