CELL :-      CELL NAME:- 449      MACHINE / STAGE:- Combo unit      OPERATION :- Free rotation

**KAIZEN THEME :-** To increased MTBF

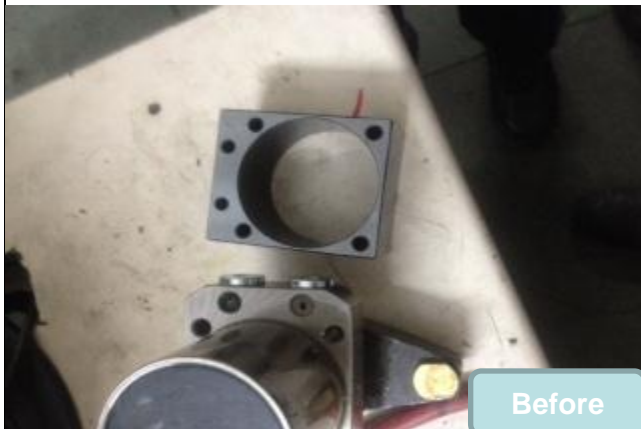
Before

**PROBLEM / PRESENT STATUS:-** Frequent hydraulic oil Empty of tank due to continue oil leaked In hydraulic cylinder manifold .

**WHY WHY ANALYSIS :-**  
**WHY 1:-** Oil leaked in manifold  
**WHY 2:-** O, ring not match in cylinder hole  
**WHY 3:-** Design problem

**ROOT CAUSE:-** Design problem
