<b>Dept. :- Assembly</b>	Activity	KK	JH	QM	PM	SHE	OT	DM	E&T	<b>Kaizen No.</b>
	Result Area	P	Q	C	D	S	M			
	Defect Type					Loss No.				<b>Team:-</b>

<b>Cell No.</b>		<b>Cell Name</b>	A336	<b>Machine</b>	Free rotation m/c	<b>Process Stage</b>	Free Rotation
-----------------	--	------------------	------	----------------	-------------------	----------------------	---------------

<b>Kaizen Theme:</b> To avoid the customer complaint.	<b>Kaizen Idea:</b> To eliminate customer complaint.
---	--

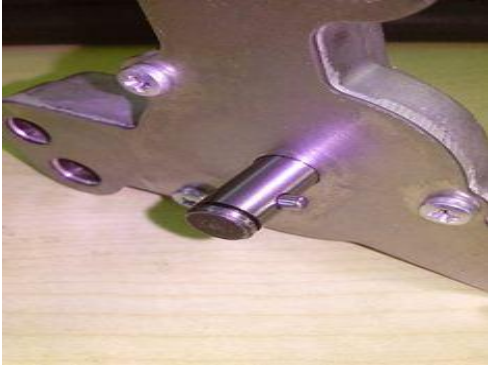
<p><b>Problem / Present Status :</b> A336 shaft drill dia. 2.53 mm is U/S.</p> <p style="text-align: center;"><b>Before</b></p>

<p><b>Why-Why Analysis:-</b></p> <p><b>Why:-</b> A336 shaft ID 2.53 mm U/S.</p> <p><b>Why:-</b>Not arrested in RPM process.</p> <p><b>Why:-</b>Pin used for RPM is having Dia. 2.00 mm which is used in assembly.</p> <p><b>Why:-</b>Pin used for insertion in shaft is U/S..</p> <p><b>Root Cause:</b> Pin used is U/S.</p>	<p><b>Results :</b></p> <p style="text-align: center;">Customer complaint in nos.</p>

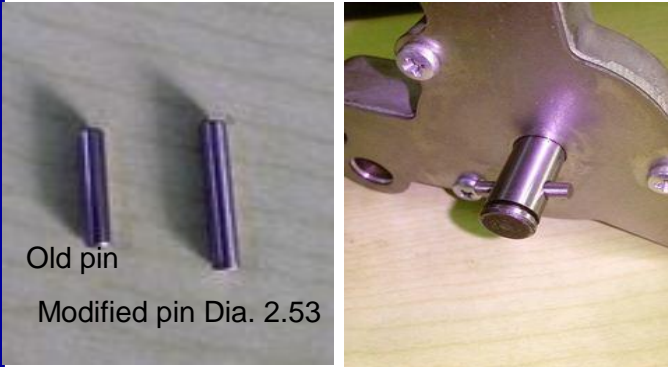
<p><b>Counter Measure :</b> use the pin of Dia. 2.53 mm for insertion in shaft ID at RPM checking stage.</p> <p style="text-align: center;"><b>After</b></p>

<p style="text-align: center;">Old pin Modified pin Dia. 2.53</p>

<table border="1" style="width: 100%; border-collapse: collapse; margin-top: 10px;"> <tr> <td style="width: 20%; text-align: center;">Before</td> <td style="width: 20%; text-align: center;">2</td> <td style="width: 20%; text-align: center;">After</td> <td style="width: 20%; text-align: center;">0</td> </tr> </table>	Before	2	After	0	<p><b>Kaizen Sustenance :</b></p> <p><b>What to do :</b> To check that modified pin is used for RPM.</p> <p><b>How to do :</b> Add point in Daily check sheet.</p>
Before	2	After	0			
<b>Scope and Plan for HD</b>						
<b>Sr. No</b>	<b>Model</b>	<b>T/ date</b>	<b>Res.</b>	<b>Status</b>		
A237 ,A207,A171,A373		Prod	C			
<p>Registration No. &amp; Date :</p> <p>Registered by :</p> <p>Manager's Sign :</p>
