IK		TPM CIRCLE NO :-	1	ACTIVITY	KK	QM	PM	JH	SHE	OTPM	DM	E & T	KAIZEN IDEA SHEET																		
Plant : P14		TPM CIRCLE NAME :		LOSS NO./STEP																											
CELL : Tensioner		DEPT :	Quality	RESULT AREA	C	Q	P	P, C	S	M, D	P, C	M																			
CELL NAME :		A545	M/C TAGE:	Broaching			OPERATION:		Broaching																						
KAIZEN THEME :		KAIZEN IDEA :																													
To improve inspection method at A545 Plunger broaching process.		By de-skilling the inspection procedure.							BENCHMARK:		----																				
									TARGET:		-----																				
									KAIZEN START:		08.10.2018																				
									TARGET DATE:		29.10.2018																				
									KAIZEN FINISH:		05.11.2018																				
PROBLEM PRESENT STATUS :		COUNTERMEASURE:							TEAM MEMBERS:																						
A545 Plunger broaching thickness confirmed with dig. Micrometer with a part tolerance of 0.025 mm need skill operator for measurement. And Inspection Time also More.		To provide attribute gauge at Plunger broaching process to confirm the broaching thickness without any difficulty and with zero inspection error. With increased efficiency.							Yogesh		T

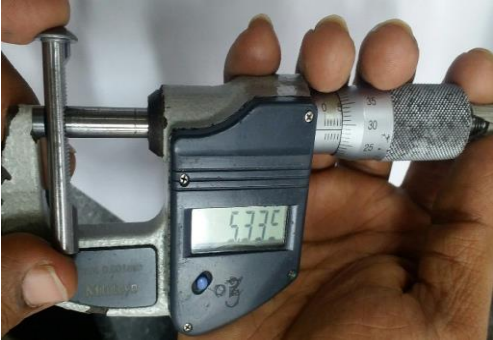
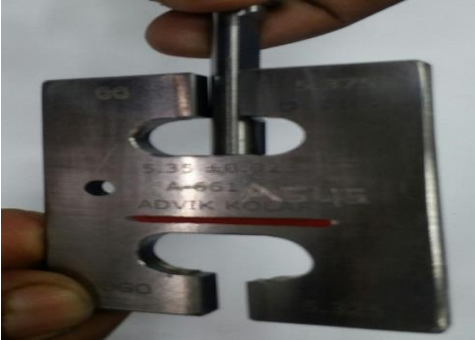
BENEFITS:-		- Rejection and rework will eliminated																				
WHY-WHY ANALYSIS:		BEFORE			AFTER			KAIZEN SUSTAINANCE																							
Why 1 : Need skilled operator to check plunger broaching thickness as the process tolerance is 0.025 mm.

WHAT TO DO:																							
Why 2 : A545 Plunger broaching thickness measured with digital micrometer may get wrong reading.								Ir-reversible kaizen																							
Why 3 : Operator skill need to use of ratchet to get accurate reading.								HOW TO DO:																							
								FREQUENCY:																							
								--																							
								SCOPE & PLAN FOR HORIZONTAL DEPLOYMENT																							
								<table border="1"> <thead> <tr> <th>SR.NO.</th> <th>CELL/PRODUCT</th> <th>TDC</th> <th>RESP.</th> <th>STATUS</th> </tr> </thead> <tbody> <tr> <td>1</td> <td>A663</td> <td>22.12.18</td> <td>Yogesh</td> <td></td> </tr> <tr> <td></td> <td></td> <td></td> <td></td> <td></td> </tr> <tr> <td></td> <td></td> <td></td> <td></td> <td></td> </tr> </tbody> </table>				SR.NO.	CELL/PRODUCT	TDC	RESP.	STATUS	1	A663	22.12.18	Yogesh

SR.NO.	CELL/PRODUCT	TDC	RESP.	STATUS																											
1	A663	22.12.18	Yogesh																												
ROOT CAUSE		RESULTS:																													
A545 Plunger broaching thickness confirmed with dig. Micrometer with a part tolerance of 0.025 mm need skill operator for measurement. And Inspection Time also More.		<p>“ ZERO Inspection Error and Inspection Time Redused to increase efficiency.</p>
