CELL :-A337	CELL NAME:- Oil Pump Line	MACHINE / STAGE :- VMC (Brother)/ Machining	OPERATION :- Operation No. 10
-------------	---------------------------	---	-------------------------------

KAIZEN THEME : To Prevent the Rejection & potential Customer Complaint of Rotor Face taper & free rotation jam.

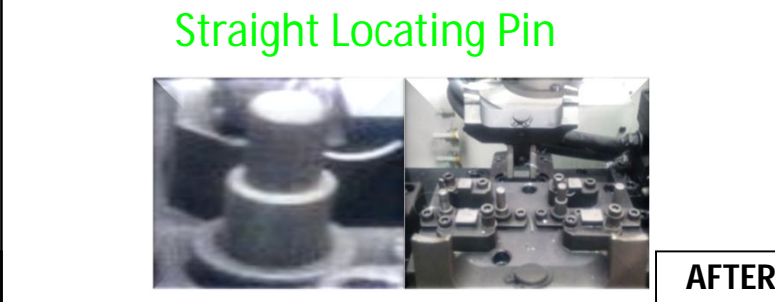
BEFORE

PROBLEM / PRESENT STATUS :- A337 Oil Pump Body Rejection In Assembly Clearance Checking Stage Due To Body Rotor Face Taper up To 30 microns & Customer Complaint May Happen For Rotation Jam & We Are Presently using Spring Loaded Taper Locating Pin For Component Locating. **Taper Locating Pin**

WHY - WHY ANALYSIS :-
Why1:- A337 Oil Pump Body Rejection In Assembly Clearance Checking Stage
Why 2:- Body Rotor Hole Face Taper Up to 30 Microns.
Why 3:- Improper Resting Of Component.
Why 4:- Spring Loaded Taper Locating Pin.

ROOT CAUSE :- Spring Loaded Taper Locating Pin.

IDEA :- Component Locating Pin To Be Modify Taper To Straight.

COUNTERMEASURE:- Component Locating Pin Modified & Body Rotor Face Taper Found 6-8 Microns & Now No Issue In Assembly Clearance Checking Stage.
