CELL :-A247      CELL NAME:- BKT      MACHINE / STAGE :- Drilling -SPM A1      OPERATION :- Drilling

**KAIZEN THEME** –To Avoid A247 BKT Inside dia 5 Counter hole face damage

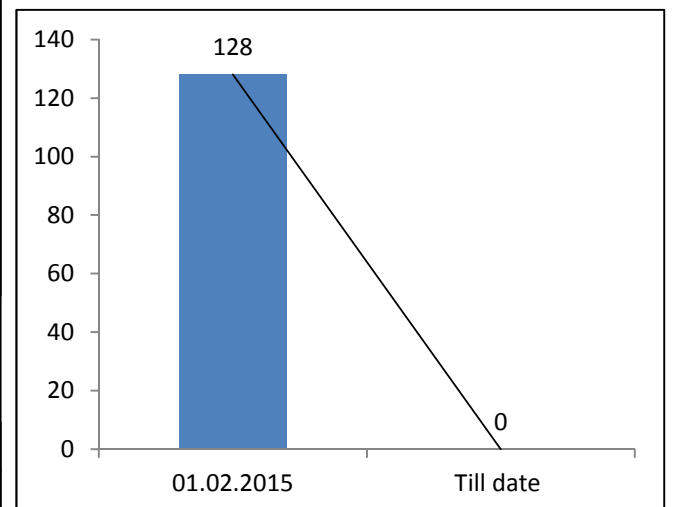
**RESULT :-**

**WHY - WHY ANALYSIS :-**  
**Why 1** – A247 BKT Counter hole face damage.  
**Why 2** - 4.2 Drill not rotate concentric  
**Why 3** –0.35 Play observed in 4.2 drill spindle (Req.20 mic).  
**Why 4** –Gear box housing wear out ( Gear box ID required 47 & actual 47.5mm ) .

**ROOT CAUSE-** –Gear box housing wear out

**COUNTERMEASURE:** 1) Gear box changed.2) Provide air purging to avoid coolant entry into bearing.
