CELL :- A247 BKT CELL NAME:- Bracket MACHINE / STAGE :- SPM OPERATION :- Tapping

KAIZEN THEME –To avoid A247 BKT M8 Tapping hole oversize

PROBLEM / PRESENT STATUS –A247 BKT M8 Tapping hole oversize

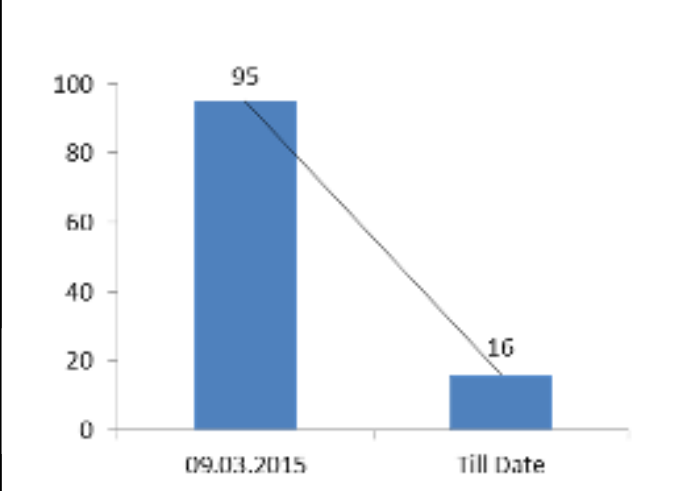
RESULT :-

WHY - WHY ANALYSIS :-
Why 1 – A247 BKT M8 Tapping hole oversize.
Why 2 –Cutting Feed low.
Why3 – Feed Gear Ratio Wrong .
Why4 - During assembly of Gear ,sequence of assembly not follow.
Why4 -No awareness

ROOT CAUSE- No awareness

COUNTERMEASURE: 1) Gear Ratio corrected.
2) Before dis assemble & assembly drawing used & sequence follow .
3) Training given to operator
