**CELL :- Tensioner** | **CELL NAME:-A157** | **MACHINE / STAGE :- Troub** | **OPERATION : Facing**

**KAIZEN THEME -To avoid** A157 Body Back facing line mark.

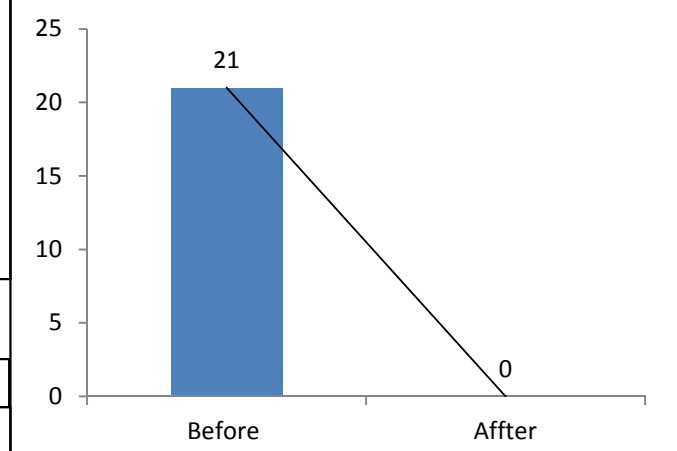
**RESULT :-**

**PROBLEM / PRESENT STATUS -**A157 Body Back facing line mark.

**Why 1** – A157 Body Back facing line mark.

**Why 2** – Play in slide .

**Why 3** – slide Tightening screw loose.

**Why 4** – Screw head worn out after long use.

**ROOT CAUSE--** Screw head worn out after long use.

**COUNTERMEASURE:-** 1) Screw changed  
2)Screw kept spare 3)Check point added in Jh Check sheet
