CELL :-      CELL NAME:- 449      MACHINE / STAGE:- Combo unit      OPERATION :- Free rotation

**KAIZEN THEME :-** To increased MTBF

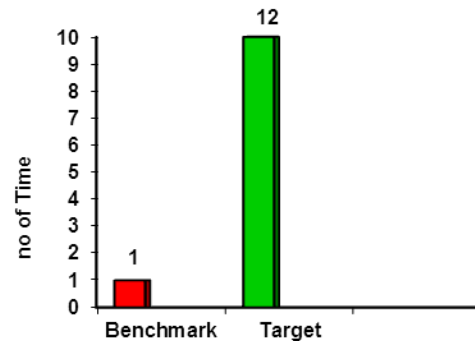
**RESULT:-** .

<b>BENCHMARK</b>	1 time in month
<b>TARGET</b>	12 time in month
<b>KAIZEN START</b>	10.11.16
<b>KAIZEN FINISH</b>	13.11.16
