CELL :- A247 CELL NAME:- BKT MACHINE / STAGE :- SPM OPERATION :- Tapping.

KAIZEN THEME –To avoid A247 BKT M8x1.25 Tapping Oversize

PROBLEM / PRESENT STATUS –A247 BKT M8x1.25 Tapping Oversize

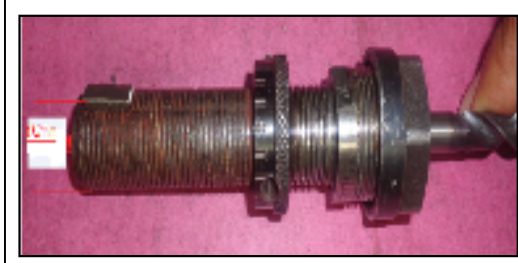
BEFORE

Holder to key face distance 17.7mm

WHY - WHY ANALYSIS :-
Why 1 – A247 BKT M8x1.25 Tapping Oversize .
Why 2 – Drill size having taper on top side 6.994 & bottom side 6.89 (Minor dia for M8 tapping require 6.647 to 6.912) .
Why 3 – Holder run out 1mm (Spec 0.02mm) .
Why 4 –Clearance between Spindle ID & Holder with key is 0.7mm.

ROOT CAUSE- – Clearance between Spindle ID & Holder with key is 0.7mm.

IDEA :- 1) Wood ruff key to be replaced & reduce gap

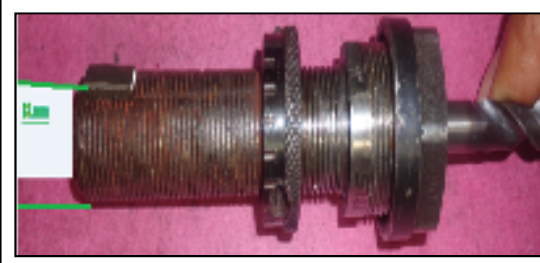
AFTER

Holder to key face distance 18.00mm

- 1) Wood ruff key replaced & reduce gap
- 2) 100 % Checking started .
- 3) After setting of holder , holder should be true .

Currently 100 % checking for M8 tapping
