CELL :- A267 **CELL NAME:- Tensioner** **MACHINE / STAGE :- CNC Turning** **OPERATION :-Grooving**

KAIZEN THEME –To Avoid recurrence of A267 Body groove uneven

PROBLEM / PRESENT STATUS –A267 Body Groove Uneven

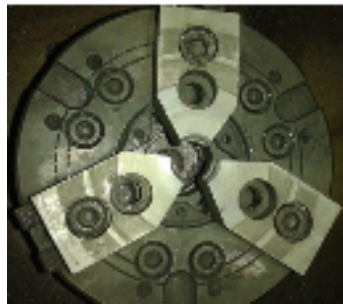
WHY - WHY ANALYSIS :-
Why 1 – A267 Body Groove Uneven
Why 2 – Part not resting Properly.
Why 3 – Both flange of Body not rest on Jaws.
Why 4 – Three Jaw chuck flange at 180° & Jaws at 120°

ROOT CAUSE- Three Jaw chuck flange at 180° & Jaws at 120°

IDEA :-Two jaw chuck to be used.

COUNTERMEASURE :A267 body shift to two jaw chuck machine & combination tool to be provided
