CELL :-A157	CELL NAME:-Tensioner	MACHINE / STAGE:- TRUB / 20	OPERATION :- Back Facing
-------------	----------------------	-----------------------------	--------------------------

KAIZEN THEME : To prevent the defect of A157 Tensioner Body Face Back Damage

PROBLEM / PRESENT STATUS:- 15 No's A157 Tensioner Body Back Face Damage during machining

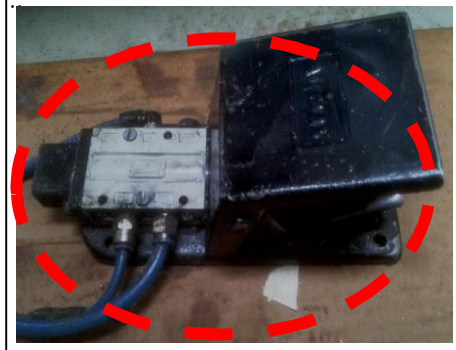
BEFORE

WHY - WHY ANALYSIS :-
Why 1 : 15 No's A157 Tensioner Body Back Face Damage during machining .
Why 2 : Excess Material Removed during Back Facing Operation (50).
Why 3 : During Facing Operation Collet holder was De-Clamped.
Why4 : Component get de clamped without completing the back facing cycle .
Why5 : Operator Pressed the Foot Pedal in Running Condition,before completion of Operation.

COUNTERMEASURE:- Electric Foot Pedal to be implemented instead of Pneumatic Foot Pedal.

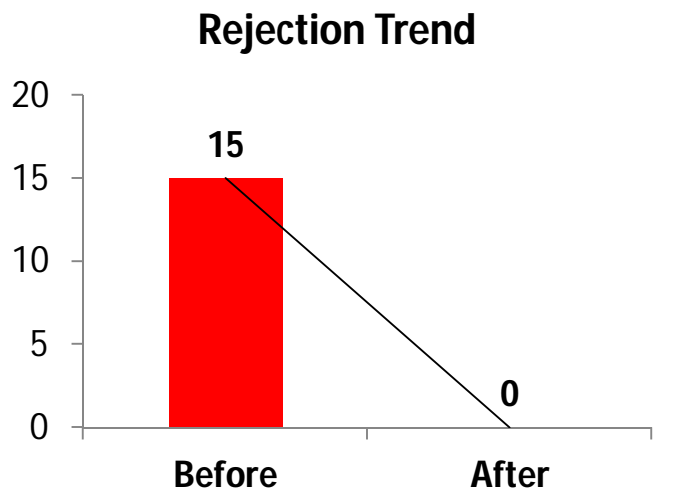
RESULT :-

ROOT CAUSE :- Poka

WHAT TO DO : Electric Foot Pedal to be installed.
HOW TO DO : Electric Foot Pedal to be implemented instead of Pneumatic Foot Pedal
FREQUENCY :-
